Ultrasonic Inspection of Titan IV Stage I Baffles

1 March 1996

J. P. NOKES
Mechanics and Materials Technology Center
Technology Operations

6. AUTHOR(S) J. P. Nokes				
7. PERFORMING ORGANIZATION NAME(S) AND ADDRESS(ES) The Aerospace Corporation Technology Operations El Segundo, CA 90245-4691			8. PERFORMING ORGANIZATION REPORT NUMBER TR-95(5530)-3

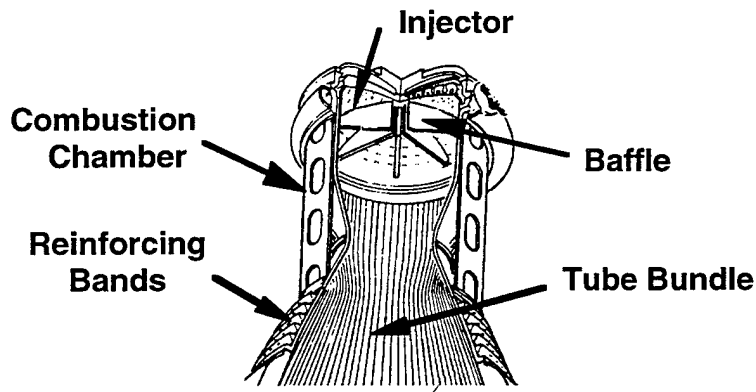
Each combustion chamber assembly on the Titan IV LR87-AJ-11 engine has seven CRES 347 stainless-steel baffles radially mounted to the face of the injector to control combustion instabilities. Some of the primary elements of the engine, including the baffles, are shown in the exploded view of the LR87 engine presented in Figure 1.

Figure 1. Location of baffles in the assembled Titan IV LR87-AJ-11 engine.

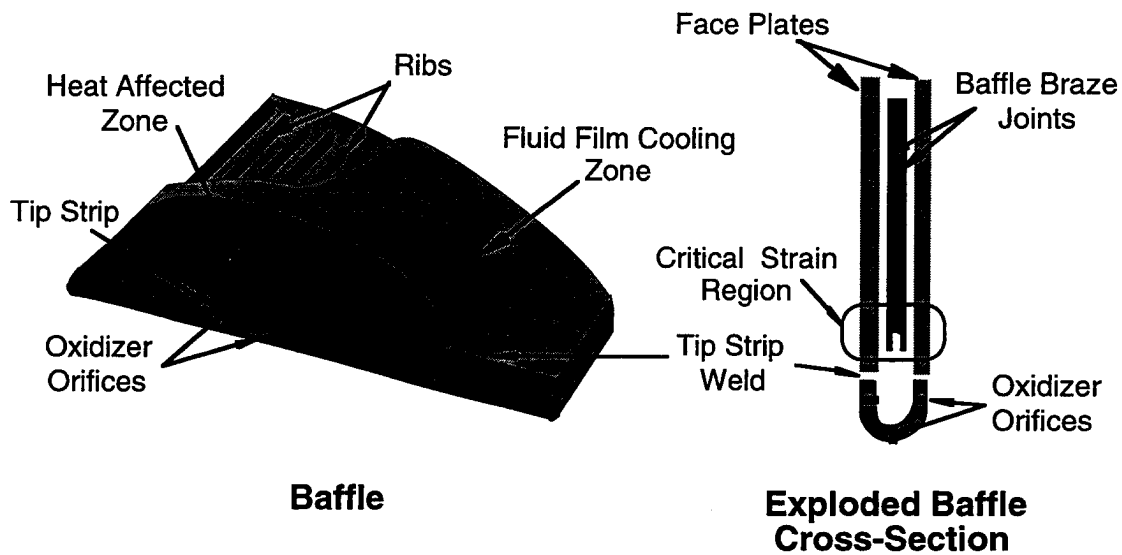
Each baffle assembly consists of a set of 16 spacers or ribs sandwiched between two face plates. Oxidizer flows through the channels formed by the ribs to regeneratively cool the baffle. Additionally, there is fluid film cooling over a portion of the baffle. The main elements and regions of a baffle assembly are identified in Figure 2.

Figure 2. Schematic of Titan IV injector baffle.

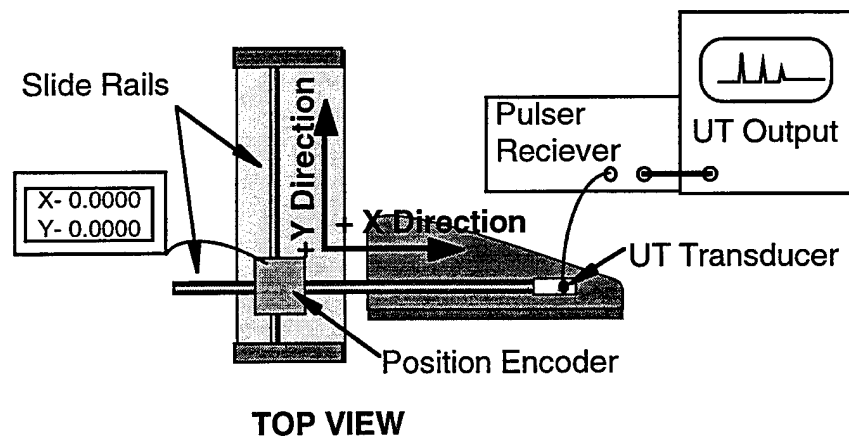
Evaluating the proposed baffle inspection technique required a test standard with known flaws. For the initial calibration standard, a two-piece baffle was obtained from the Titan Program Office. This two-piece baffle was used for initial testing only. Debonds were simulated in the baffle by removing material from selected ribs with an end mill. For the preliminary calibration standard, two 0.050-in. sections were removed from a rib in the central portion of the baffle. In addition, the lengths of three ribs were reduced by 0.035, 0.050, and 0.080 in. In the initial studies, a Panametrics, 15-MHz, focused pencil-probe transducer was employed in conjunction with a Panametrics Model 5052 pulser/receiver and a Fluke Model 97, 50-MHz oscilloscope. An Amdata Model 4020 X-Y scanner was used to accurately position the UT transducer on the baffle standard, as depicted in Figure 3.

Figure 3. Schematic diagram of the bench top scanner used for the initial testing of the ultrasonic baffle inspection procedures and equipment.

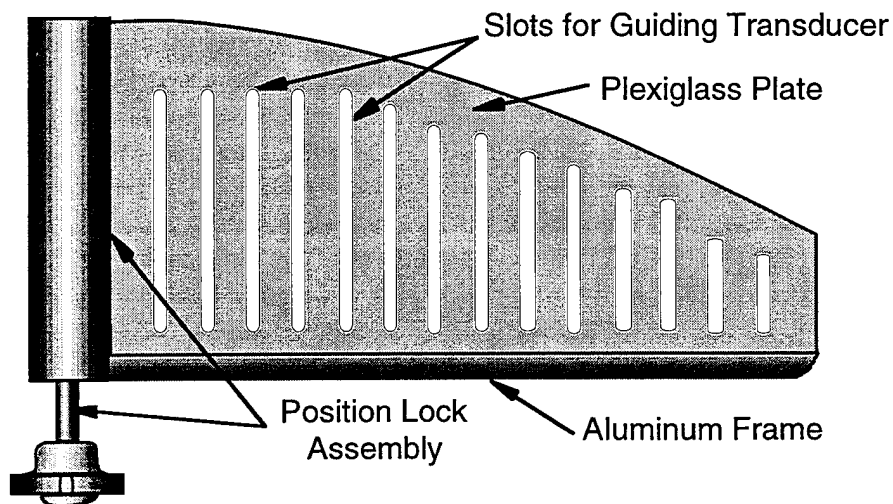
Friction held the guide onto a baffle for the initial fit up. The tool was then adjusted to center the slots over the ribs. If necessary, the template could be snugged down further using the position lock identified in Figure 7. The inspection was performed using a Krautkramer Branson, Model CL204 thickness gauge with a 0.125-in.-diam., 20-MHz transducer. During development of the inspection procedure at Aerojet's Sacramento facility, the aforementioned equipment was found to provide the 0.125-in. debond resolution required in the "non-critical" rib regions. Use of the thickness gauge and slightly larger transducer, as opposed to the focused transducer used in laboratory tests, made positioning of the transducer easier for the inspector, particularly while working in the combustion chamber. The Model CL204 thickness gauge automatically converts the time-of-flight information from the received echoes into a thickness measurement. Using this equipment on a baffle having a nominal

Figure 7. Transducer guide for baffle inspection.

thickness of 0.25 in. would result in a thickness measurement of (1) 0.25 in. if both faceplates are properly bonded, (2) 0.17 in. if the back-faceplate is debonded, and (3) 0.08 in. if the front-faceplate is debonded.

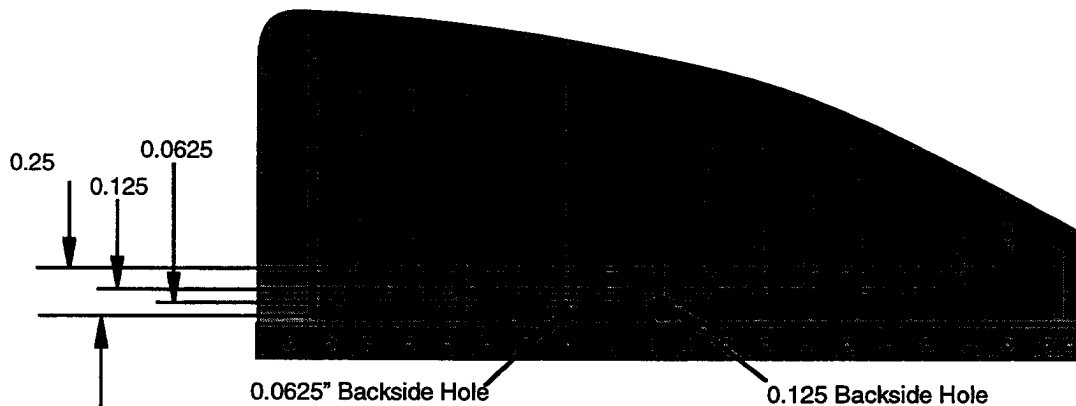
The template allowed the inspector to make good measurements for the majority of the rib/faceplate interfaces while working within the engine. However, as previously mentioned, the template did not address the inspection problems at the rib tips. The rib tip inspection procedure and tooling were finalized while working in conjunction with Aerojet NDE engineers at their Sacramento facility. An important part of preparation for the tip inspection was fabrication of the calibration standard shown in Figure 8 from a three-piece production baffle. As indicated in the figure, 0.0625 to 0.25 in. of material was removed from several of the tips to simulate front-faceplate debonds. In addition, the back-faceplate was removed for two ribs to simulate back surface debonds of 0.125 and 0.0625 in. As mentioned above, a Panametrics focused probe used in conjunction with a pulsar/receiver and oscilloscope was a successful combination during laboratory tests. By comparing measurements on the calibration standard, it was found that the same probe used in the coarse inspection could be substituted for the Panametrics focused probe while maintaining tip resolutions of better than 0.1 in. Using the tools and procedures developed at both the Aerospace and Aerojet facilities, the baffles on the K-23 vehicle were inspected on March 1 and 2, 1995, at CCAFS. No UT indications were reported during the K-23 baffle inspection.

Figure 8. Baffle calibration standard used during the baffle inspection procedure development and the K-23 vehicle inspection.
